**Flood Control Project Maintenance
Levee Inspections****LMA District Cover Sheet****Spring 2014 Levee Inspection Results****Levee District No. 0001 (Sutter County)**

Levee Inspection Report By Mile - Spring 2014

| Waterway | Bank | Unit Miles | Inspection Start/End | Inspector |
|---|---|---|---|---|
| Unit No. 01 Feather River | Right | 16.65 | 03/11/2014 03/11/2014 | Matthew Hoffman |

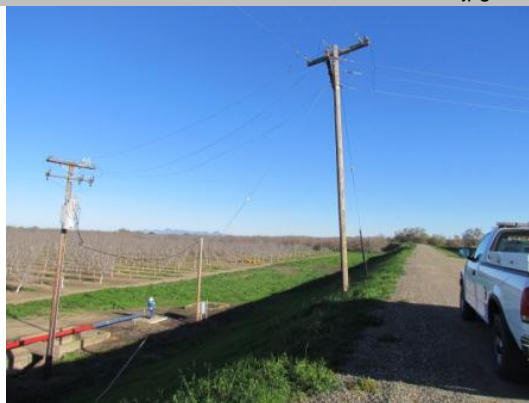
Photo 1 of 1 : mhoffman_s_20140311_263.jpg

| Pole Inspector Comments: Power pole set on landward levee slope. Spring 2014. | | | | | |

This photo was taken from the crown of the levee facing north looking at a power pole set in the landward levee slope. Spring 2014

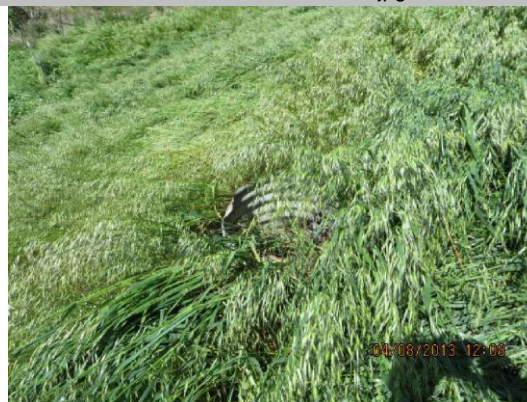
Photo 1 of 1 : UCIP_457.jpg

| UCIP Comments: Siphon breaker cap missing. Sump pump and gate valve at landward toe not found may be due to dense vegetation. | | | | | |
| FIELD_STRUCT_DESC: A 8-inch steel pipe through levee, 4.6-feet below the crown. Siphon breaker in corrugated metal riser on landward slope. | | | | | |

LS- CMP riser on levee slope with dense vegetation.

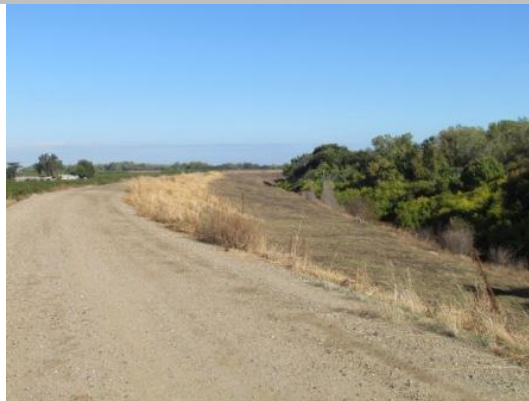
Photo 1 of 1 : mhoffman_s_20140306_002.jpg

Photo taken from levee crown looking north at vegetation on the waterward slope.

| Remove the wild growth other than native grasses from the levee slopes. | | | | | |

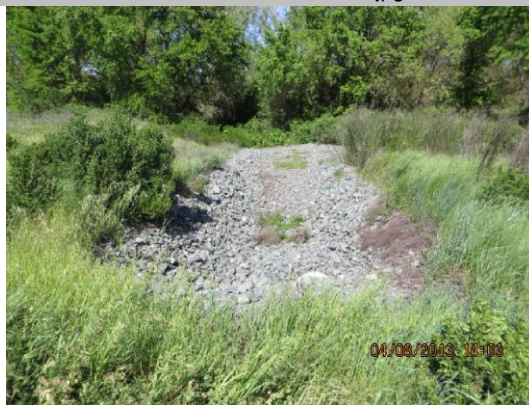
Photo 1 of 1 : UCIP_464.jpg

| UCIP Comments: Needs removal of blockage by riprap rubbles. | | | | | |
| FIELD_STRUCT_DESC: 1 of 2. 2- 16-inch steel drainage pipe. Riprap | | | | | |
| discharge structure on WS. Flap gate not properly closed. Pump station | | | | | |

WS- discharge riprap/rubble channel

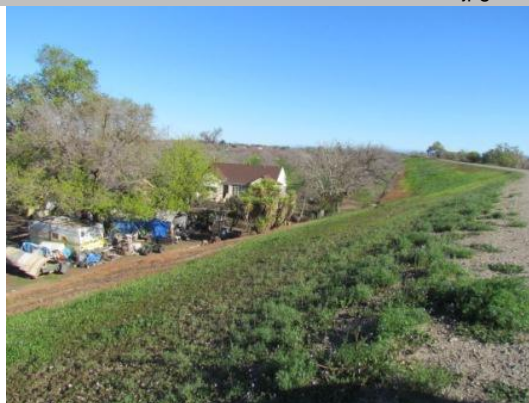
Photo 1 of 1 : mhoffman_s_20140311_264.jpg

| Inspector Comments: Landscaping on landward levee slope. Spring 2014. | | | | | |

This photo was taken from the crown of the levee facing north looking at vegetation on the landward slope. Spring 2014.

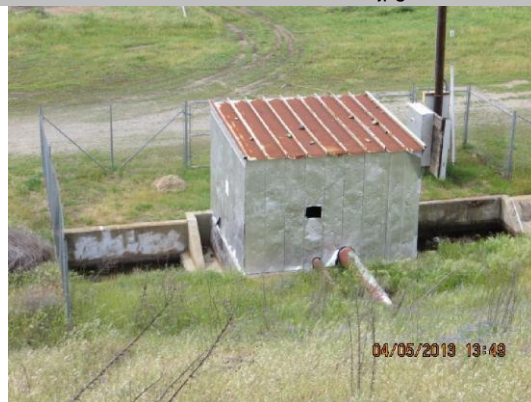
Photo 1 of 1 : UCIP_522.jpg

| UCIP Comments: No flap gates on waterward end. Road pavement cracked along pipe, it needs more investigation. | | | | | |
| FIELD_STRUCT_DESC: 1 of 2. A 6-inch pipe (of 6-inch and 16-inch-pipes) through levee, 6.0 feet below crown. Siphon breakers in corrugated metal pipe risers on waterward shoulder. Pump house at landward toe. | | | | | |

LS- pipes and pump house on concrete base.

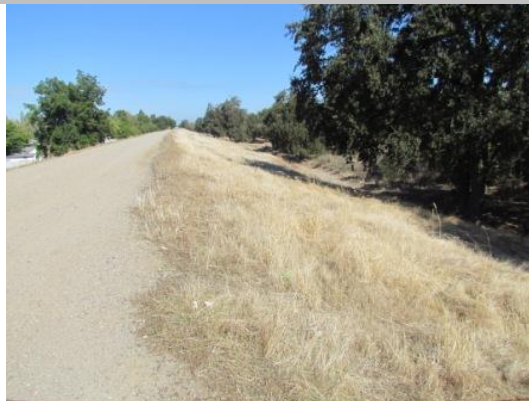
Photo 1 of 1 : mhoffman_s_20140306_003.jpg

| Remove the wild growth other than native grasses from the levee slopes. Inspector Comments: Due to fires in the valley the district was unable to burn this section. District stated that they will drag the area to control vegetation. | | | | | |

Photo taken from levee crown looking north at vegetation on the waterward slope.

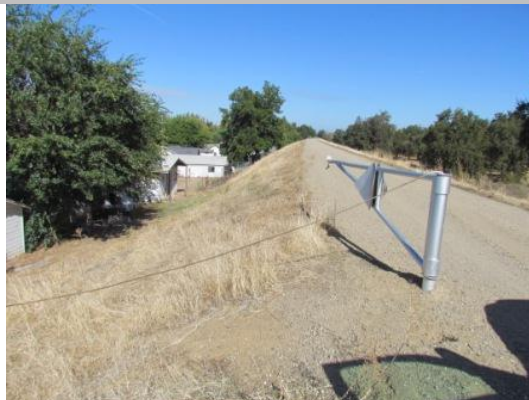
Photo 1 of 1 : mhoffman_s_20140306_004.jpg

| Remove the wild growth other than native grasses from the levee slopes. Inspector Comments: Due to fires in the valley the district was unable to burn this section. District stated that they will drag the area to control vegetation. | | | | | |

Photo taken from levee crown looking north at vegetation on the landward slope.

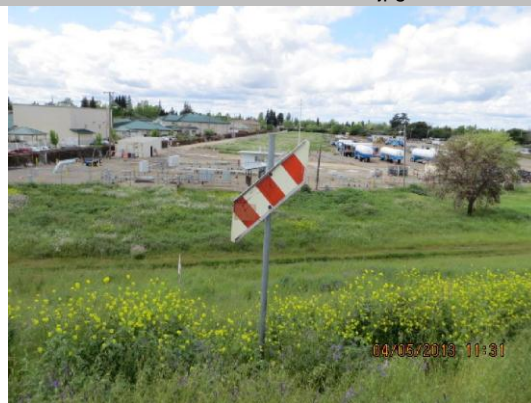
Photo 1 of 1 : UCIP_528.jpg

| UCIP Comments: Only a gasoline indicator found on LS. Needs gasoline marker also on WS. | | | | | |
| FIELD_STRUCT_DESC: A 16-inch gas line through levee, 3.5 feet below the crown. | | | | | |

LS- gasoline marker on levee slope

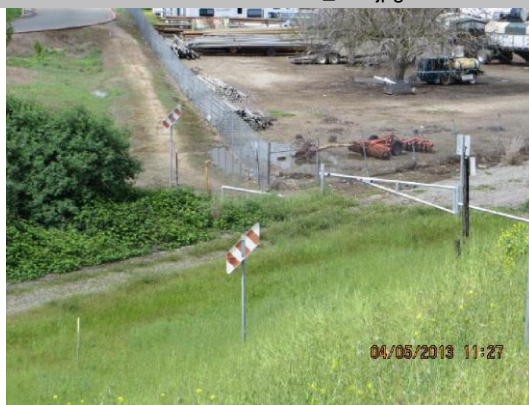
Photo 1 of 1 : UCIP_531.jpg

| Inspector Comments: FS_ID:12104 EP_NO: 17259 Repair Type: Crossing Status: UCIP Comments: Found an indicator only on LSNeeds an indicator also on WS. FIELD_STRUCT_DESC: An 8-3/8-inch-wide Electrolysis Test Station (ETS) at a depth of 4 feet and connect it to the existing 8-inch metal gas line within the waterside levee toe of the right (west) bank of the Feather River. FS Date: 4/5/2013 | | | | | |

LS- gasline indicators on levee slope and across.
